Behaviour of steel moment connections with a single flange rib

Abstract

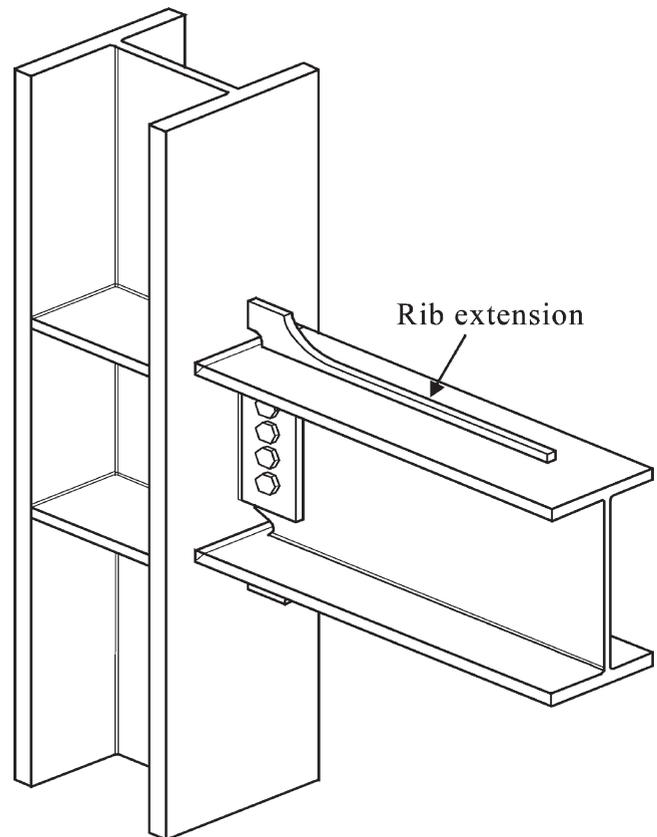
Fig. 1. Lengthened flange rib strengthened connection.

In this work, a single lengthened rib is designed to be welded to beam and column flanges in the plane of both the beam web and the column web. Fig. 1 illustrates the configuration of the connection strengthened by lengthened ribs. Unlike typical triangular rib plates, the lengthened rib consists of three parts, which are a main reinforced part, a curved part, and an extension. The curved part is intended to provide a smooth transition

from the main reinforced part of the rib to the rib extension, and to prevent undercutting of the rib plate during manufacture and possible crack initiation.

The single rib plate welded to the plane of the column web enhances the transfer of force to the column, since both rib plate and column web are in the same plane. Apparently, the possible failure of out-of-plane distortion of the column flange caused by two spaced ribs is eliminated.

The rib extension is designed to attenuate the potential stress concentration in the beam flange at the rear end (the end away from the column face) of the triangular rib, and prevent the tearing of the beam flange. The purpose of the rib extension is further to move the plastic hinge of the beam away from the column face, and form the plastic hinge in the beam starting at the front end of the rib extension. The formation of the plastic hinge in the beam leads to large plastic rotations that permit hysteretic dissipation of energy during a severe earthquake. Furthermore, the rib extension creates an extended yielding zone.

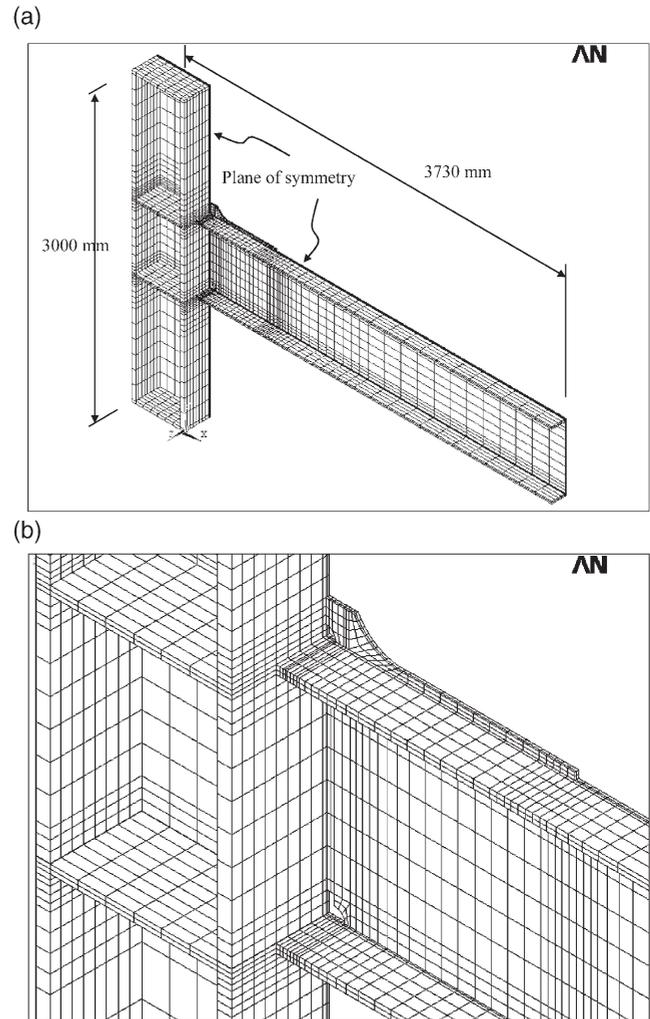
Fig. 2. Three-dimensional finite element mesh.

The general purpose finite element program ANSYS [19] was used for this numerical study. A three-dimensional finite element model was generated to represent a structural subassembly. Fig. 2 presents the finite element mesh. This subassembly was an exterior beam-to-column connection that was isolated from the midheight of two adjacent floor columns and the mid-span of the beam. Only half of the subassembly was modeled because of the symmetry of the model about the plane at the beam web and the column web. The beam was assumed to be a rolled H-shaped steel of $H700 \times 300 \times 13 \times 24$ (dimensions in mm for beam depth, width, web thickness, and flange thickness, respectively), confirmed to ASTM A36 material. The column was assumed to be an $H550 \times 550 \times 36 \times 40$, confirmed to ASTM A572 Gr. 50 material. The lengthened rib was 22 mm thick, 95 mm high, and 700 mm long with a 20 mm high extension. Ignoring the shear tab, the beam web was modeled to be welded directly to the column flange to simplify the modeling. Nevertheless, weld access holes were modeled as closely as possible to identify the nearby stress. Deformation constraints, hinged supports provided at both ends of the column, were assumed to be consistent with the subassembly and the test specimen.

Brick elements with eight nodes 24 nodal degrees of freedom, three translational DOFs at each node, were used to model the steel shape. The model comprised 4706 elements and 8072 nodes. The yield stresses used to model the beam and the column were 310 and 380 MPa, respectively, to account for the higher actual material strength. The stress-strain relationship for structural steel used in the analysis was modeled as a bilinear relation with linear elastic and strain hardening behaviour. The modulus of elasticity of 200 GPa was assumed for the elastic range and 4% of that was specified for the modulus in the strain hardening range. Von Mises yield criterion and the isotropic hardening rule were employed to define the plasticity. The load was applied by imposing incremental vertical displacements, in a monotonic fashion, at the beam tip during the analysis.

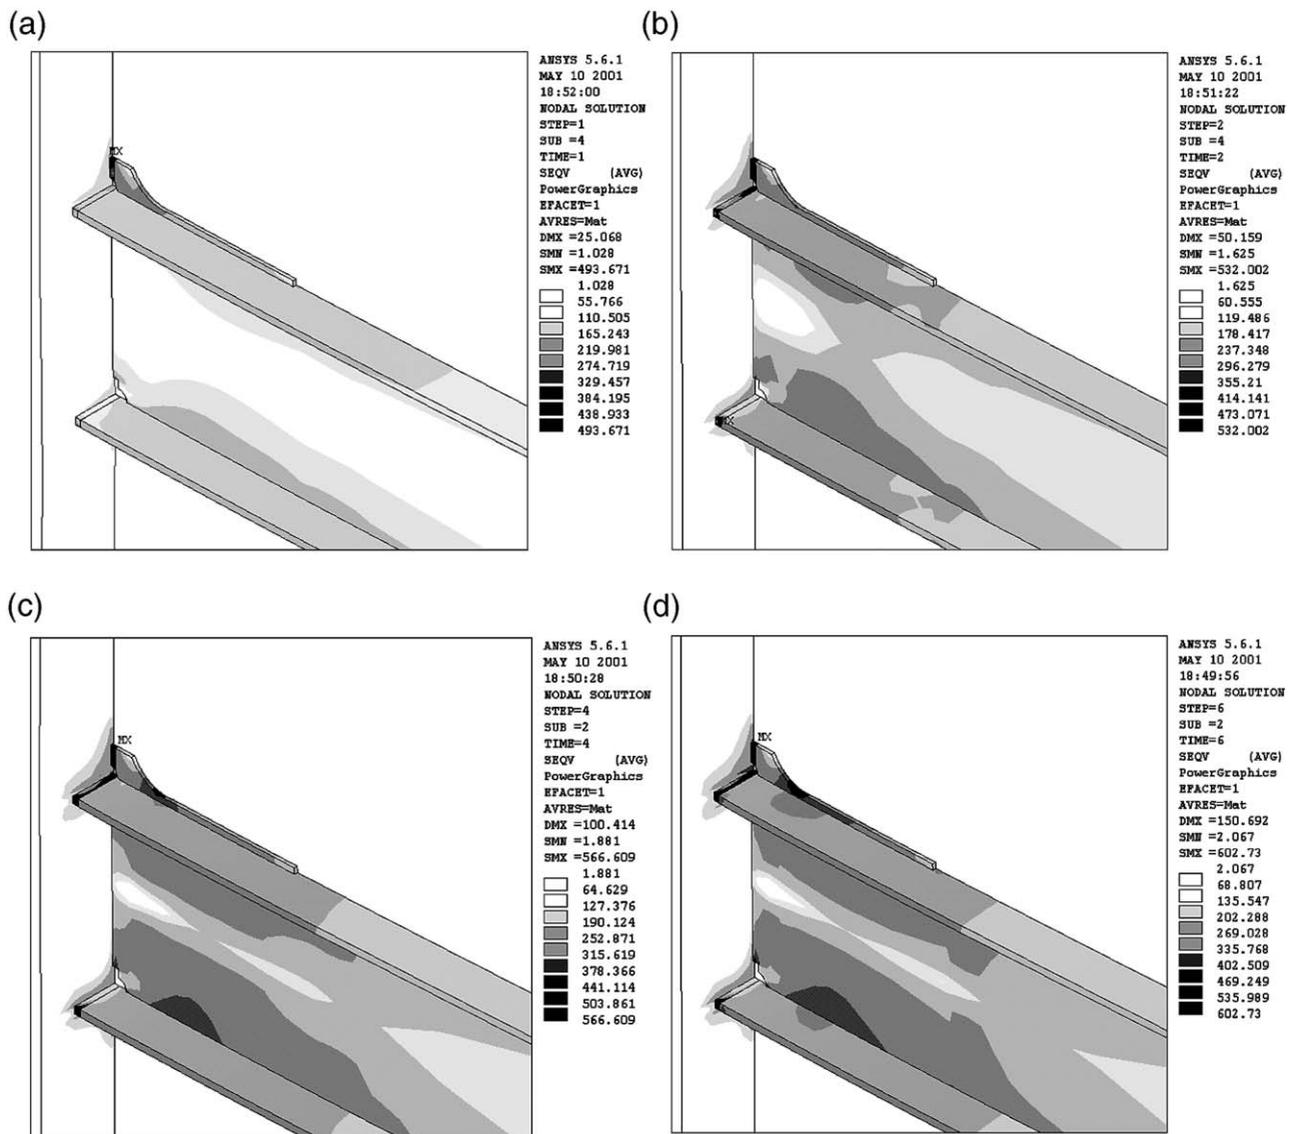
Fig. 3. Von Mises stresses distribution at various beam tip displacements.

According to the above figures, the highest stress at each stage was in the weld metal between the rib plate and the column flange, and in the complete joint penetration weld. Notably, however, the strength of the weld metal usually far exceeded that of the structural steel. The yielding of the beam was initiated in the beam flange at the front part of the rib extension. Significant

yielding and plastification of the beam occurred in the beam flanges and the beam web within the rib extension. It was also evident that no sign of the development of high stresses was found near weld access holes. No localized high stress concentration was observed in the beam flange at the rear end of the rib because of the effect of the rib extension. These observations clearly indicate that lengthening the rib leads to the formation of the plastic hinge in the beam section away from the column face. The energy dissipated within the beam section is deemed to be more reliable than that dissipated starting from the face of the column.

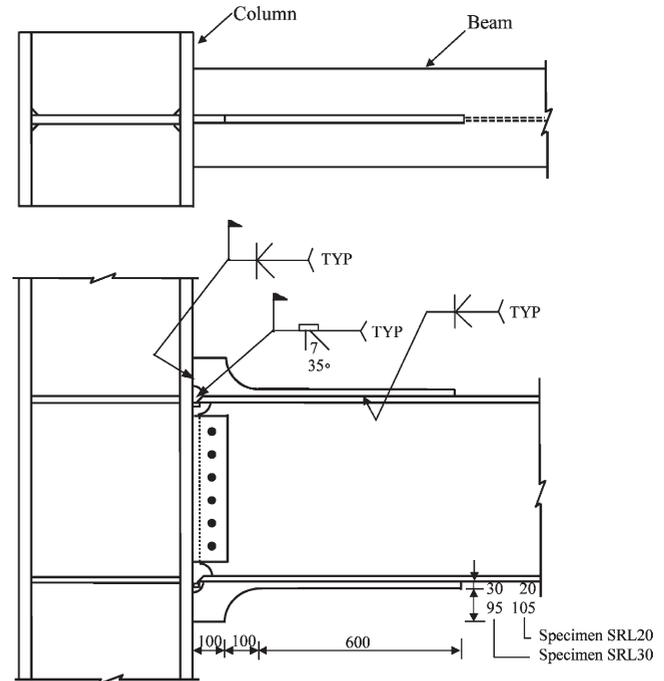
Fig. 4. Connection details of specimens SRL30 and SRL20.

Fig. 4 depicts the connection details. Both specimens had a rib 125 mm maximum high and 800 mm long. The height of the rib was limited to be less than the thickness of the concrete slab. The length of the rib extension was chosen to be equal to the depth of the beam. Specimen SRL30 used a 30 mm thick rib with a 30 mm high rib extension while specimen SRL20, less reinforced, used a 20 mm thick plate and a 20 mm high

rib extension. The design of the ribs used for the specimens was more conservative than that adopted in the finite element analysis. In regard to the welding procedure, the flange rib was welded first by welding the rib plate to the beam flange along the beam centerline. This welding can be performed in the shop to prevent

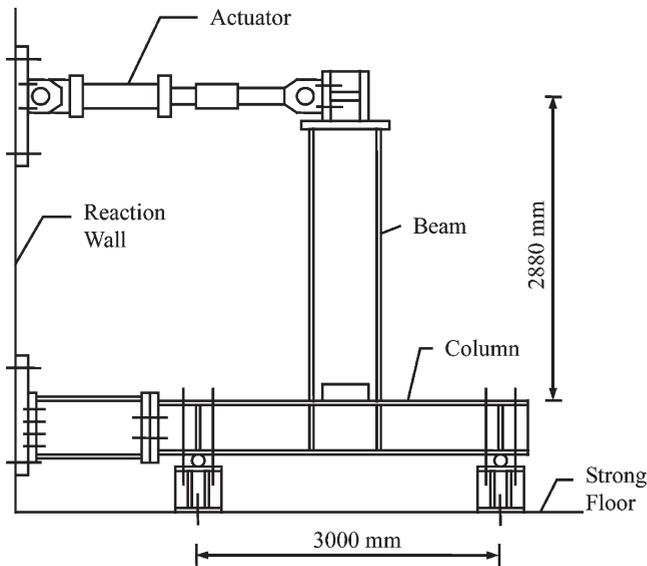
Fig. 5. Schematics of test setup.

The test setup, as shown in Fig. 5, simulates the boundary conditions of the subassembly. Cyclic loading was imposed by applying a predetermined cyclic incremental displacement history at the beam tip. The ATC-24 [21] testing protocol shown in Fig. 6 was adopted for this testing history. Imposed displacement

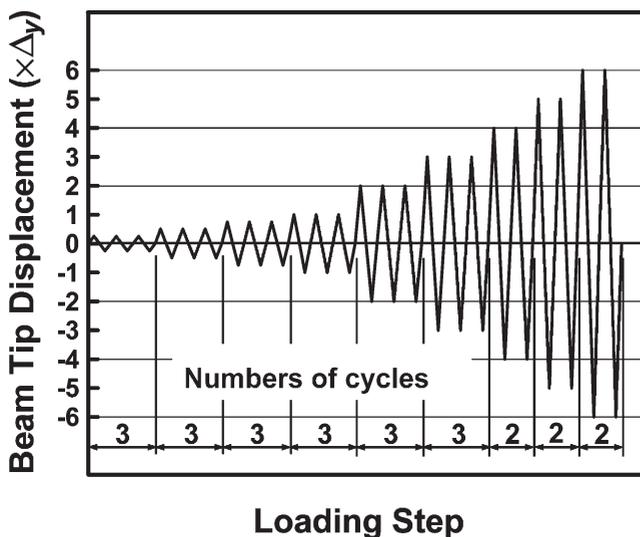
Fig. 6. Loading history.

amplitudes were in multiples of Δ_y , 14.5 mm, which represented a story drift angle of 0.46%. A lateral support near the actuator was provided to prevent lateral deformation of the beam and damage to the actuator. Global deformation of the specimen was measured during the test to determine the beam tip deformation components contributed from column, panel zone, and beam.

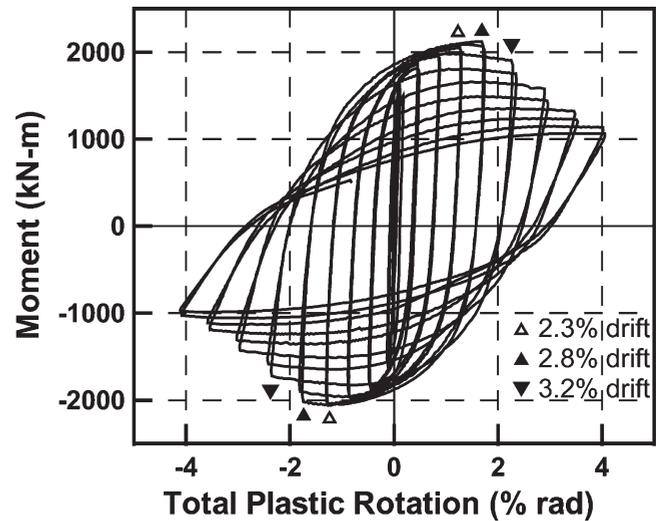
Fig. 8. Specimen SRL30 moment-plastic rotation response.

Fig. 8 plots the relationship between the moment and the total plastic rotation. The moment was calculated from the actuator loads multiplying the distance to the column face. The total plastic rotation was computed by subtracting the elastic rotation from the total rotation, i.e., the story drift angle. Strength deterioration revealed in the moment-plastic rotation curves is due to the local buckling of the beam flanges, beam web, and the lateral torsional buckling of the beam. Specimen SRL30 developed a total plastic rotation of 4% radians before the test was terminated because of excessive lateral torsional buckling and significant strength degradation. At the end of the testing, fracture of the rib plate was developed at the front end of the rib extension. At the same location, a small crack was also observed in the weld between the rib plate and the beam flange.

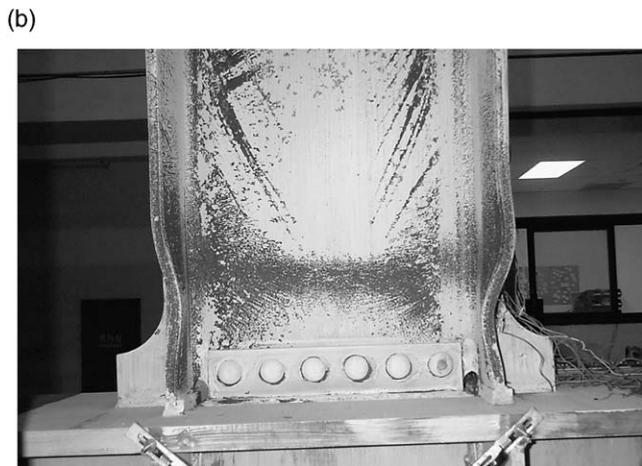
Fig. 7. Yielding and buckling pattern of specimen SRL30 at 3.2% drift.

As intended, the specimen initially yielded in the beam flange located at the rib extension. During the cycles of 2.3% story drift, the beam flanges at both ends of the rib extension exhibited minor local buckling. Story drift was calculated by the displacement at the beam tip divided by the length to the centerline of the column. Slight lateral torsional buckling was noticed during the cycles of 2.8% story drift since the lateral restraint was not sufficiently stiff, causing lateral torsional buckling of the beam. Fig. 7 shows the yielding and buckling of the beam at a story drift of 3.2%.

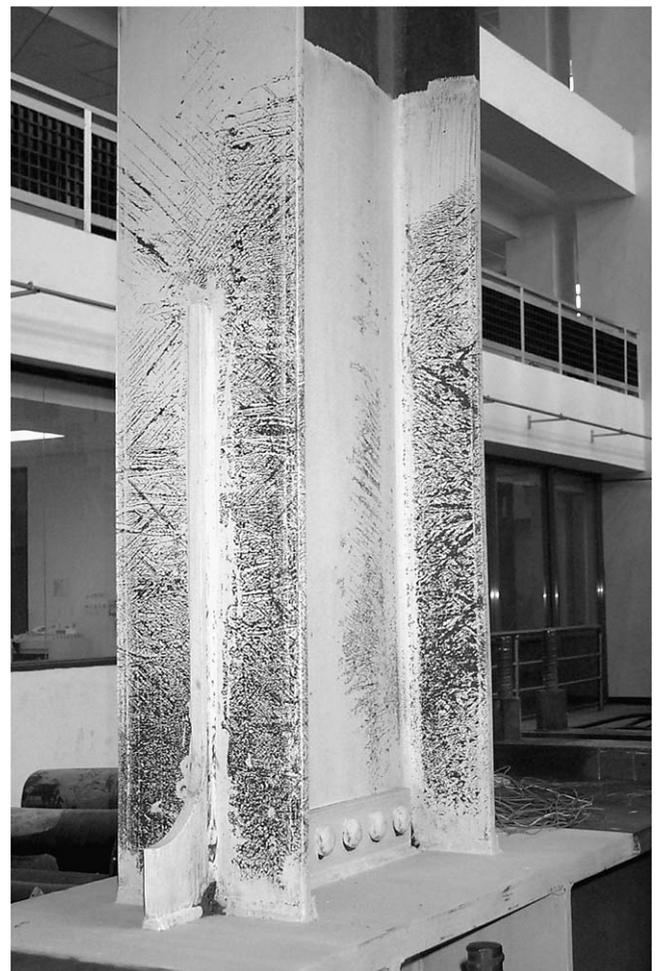
Fig. 9. Formation of beam flange yielding of specimen SRL20 at 2.8% drift.

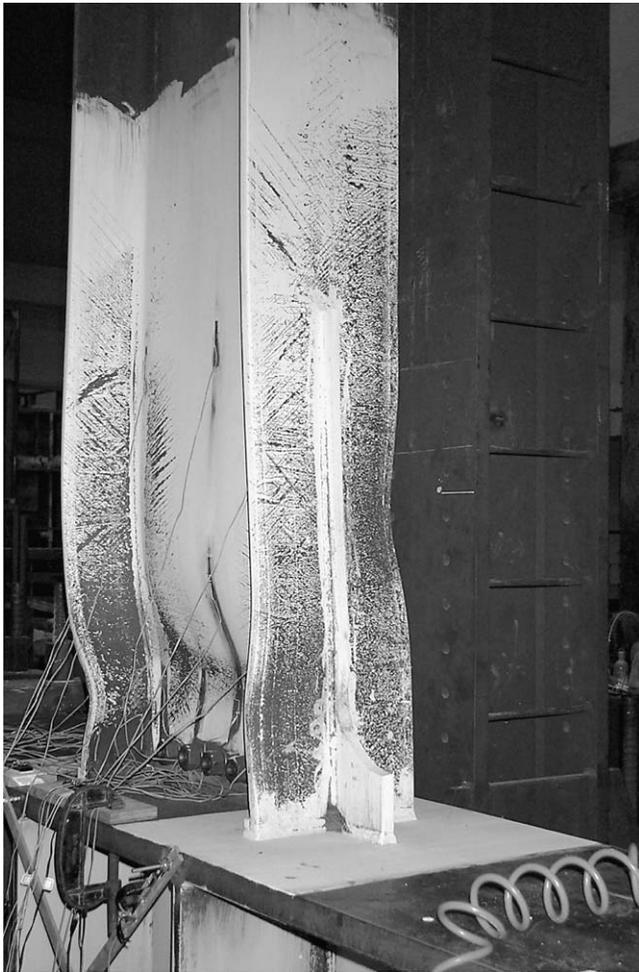
Fig. 10. Local buckling in specimen SRL20 at 3.7% drift.

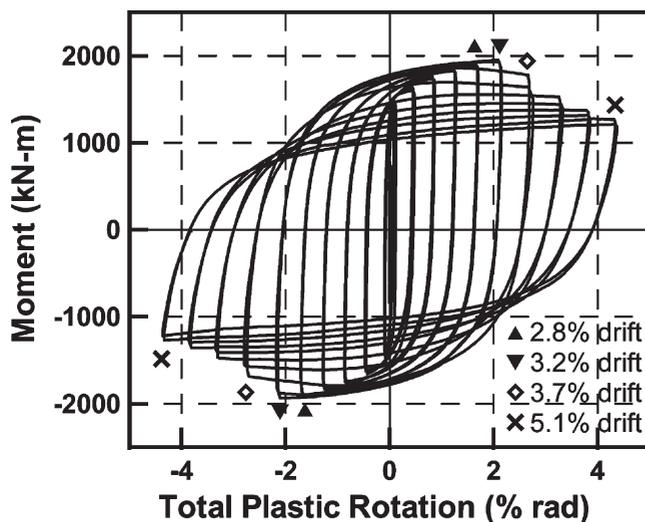
Fig. 11. Specimen SRL20 moment-plastic rotation response.

SRL20 absorbed a significant amount of the inelastic energy. Specimen SRL20 achieved a total plastic rotation of 4.4% radians while the flexural strength still exceeded the nominal plastic flexural strength of the beam. The final failure was due to a crack occurred at the front end of the rib extension, and the crack penetrated into the beam flange, at a story drift of 5.1%.

When compared with the hysteresis curve of specimen SRL30, hysteresis curve of specimen SRL20 demonstrates gradual deterioration in strength. Lateral torsion buckling of specimen SRL30 occurred at 2.8% drift while that of specimen SRL20, with stiffer bracing, happened at 3.2% drift. As indicated in the moment-plastic rotation curves, shown in Figs. 8 and 11, the strengths of both specimens dropped right after the lateral torsional buckling occurred, and specimen SRL30 showed more
